**April 2000**

# MAINTENANCE BULLETIN

**Alfa Company**

SUBJECT: Troubleshooting and Repair of Serpentine Belt and Bracket System

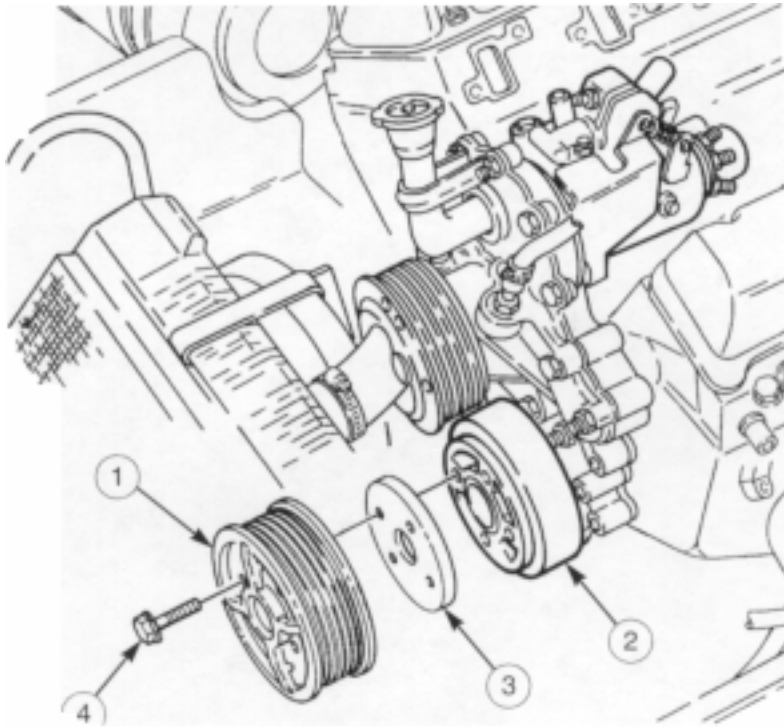
7. Remove four screws (4), crankshaft isolator pulley (1), and spacer (3) from damper (2) and check for debris between crankshaft isolator pulley (1) and spacer (3), or failed rubber isolator as shown in figure 7. Clean or replace parts as necessary.

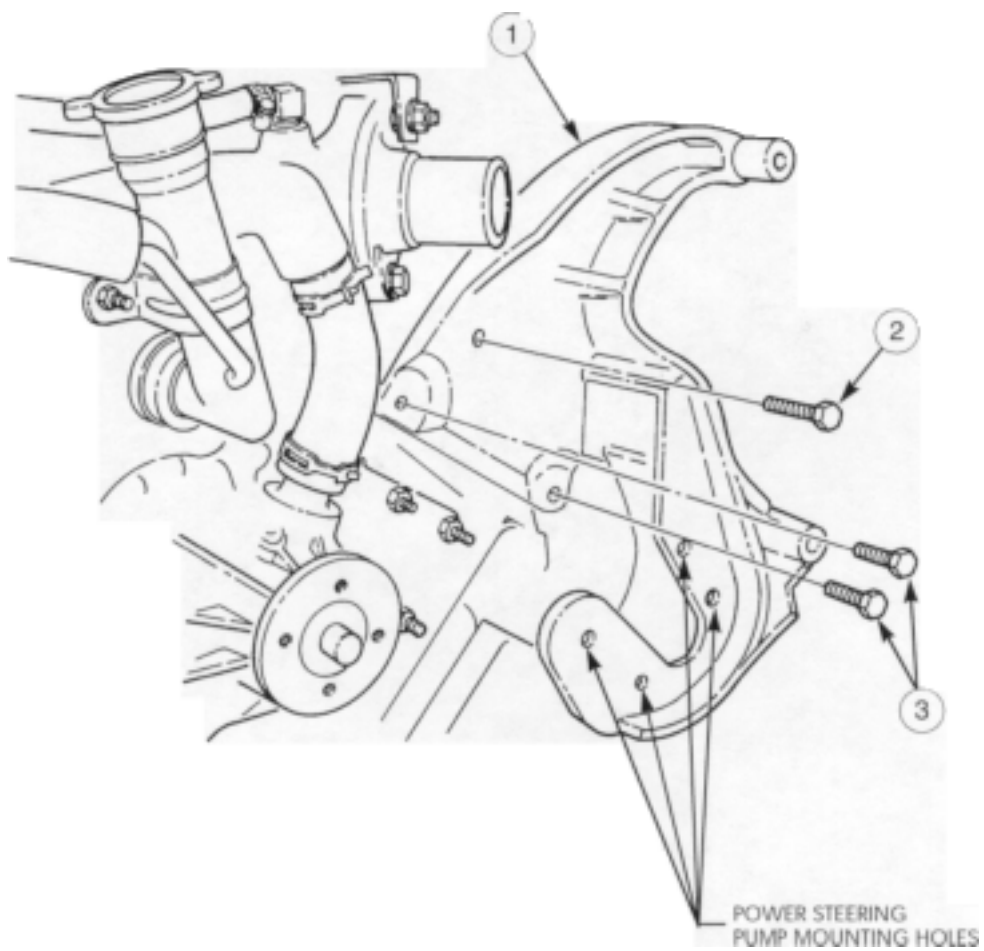
Figure 9

9. Check for loose screws (2) and (3) on alternator/power steering mounting bracket (1) as shown in figure 9. If all screws are tight and alignment tool will not fit behind crankshaft isolator pulley, remove and replace alternator/power steering mounting bracket (1) (refer to TM 9-2320-387-24 or TM 9-2320-280-20), and recheck with alignment tool.

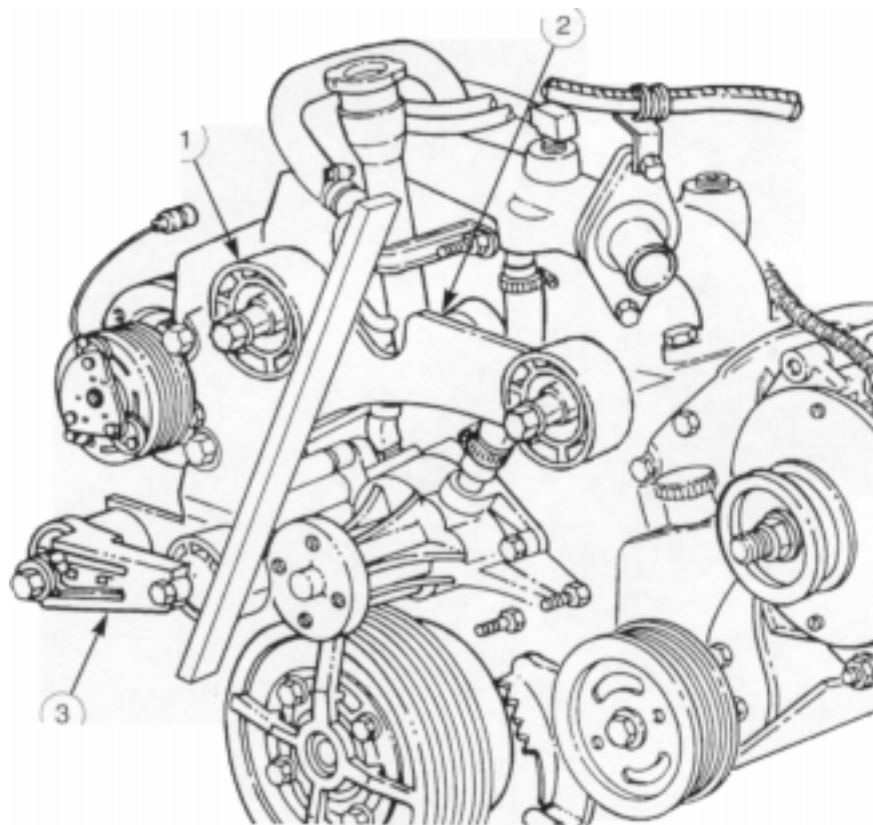
10. Check alignment of belt tensioner (3) to idler pulley (1) by placing a straight edge on pulley front face of belt tensioner (3) and to the side of idler pulley (1) or over the front face of pulley (1) as shown in figure 10. Face-to-face clearance must not exceed  $\pm .060$  in. as shown in figure 11. If clearance exceeds  $\pm .060$  in., replace idler pulley mounting bracket (2) (refer to TM 9-2320-387-24 or TM 9-2320-280-20), and recheck clearance.

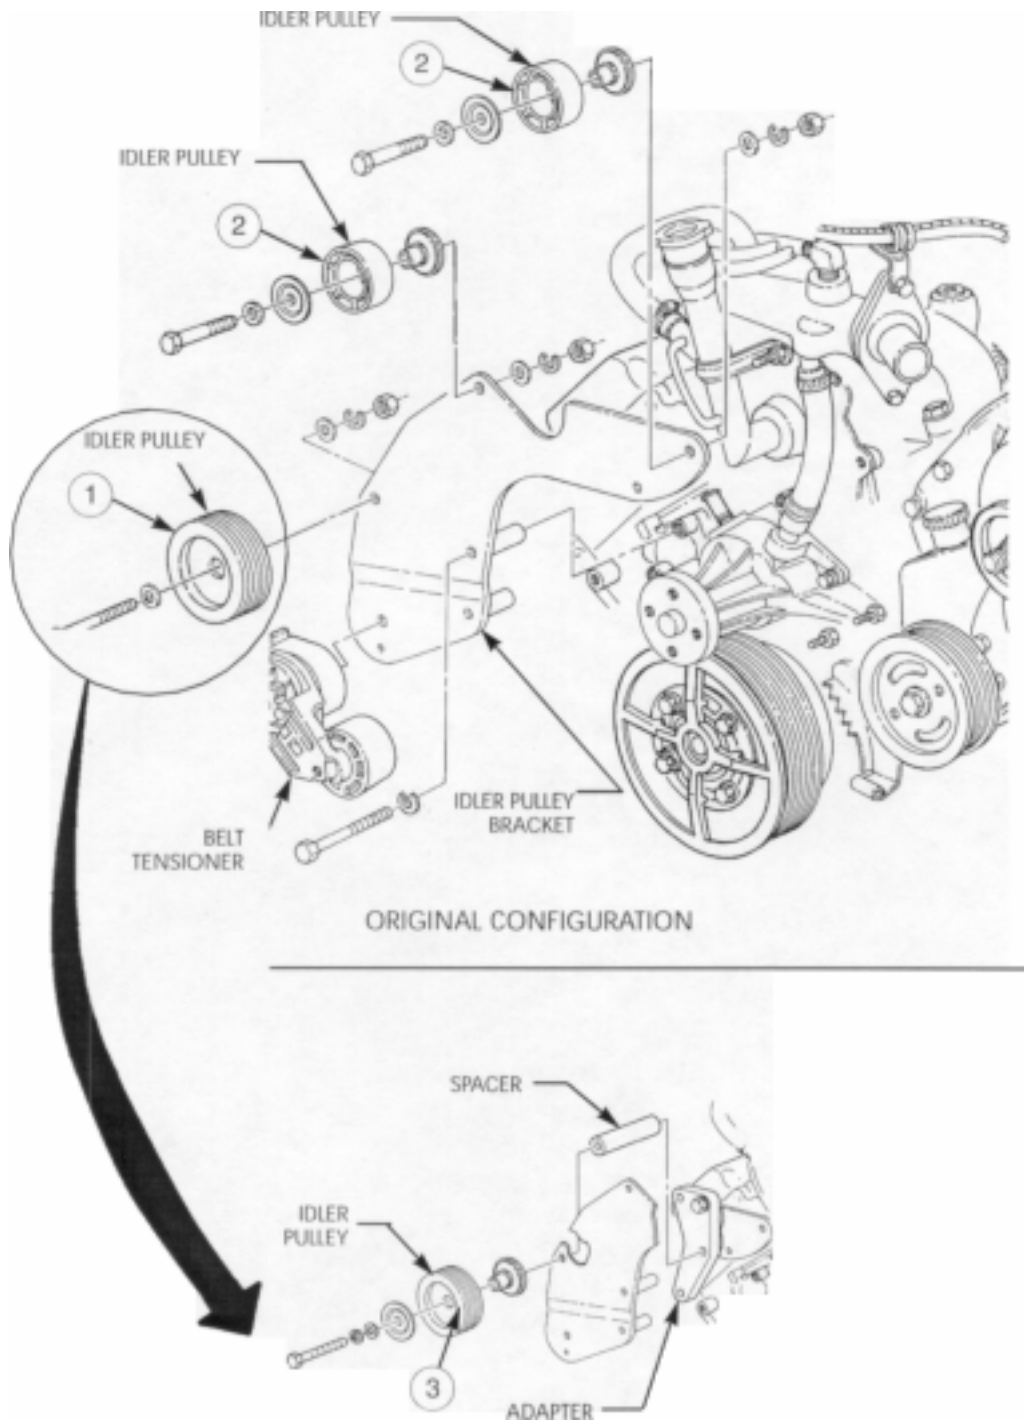
**UPDATED  
CONFIGURATION**  
Figure 12

11. Check idler pulley (1) used on vehicles without air conditioning as shown in figure 12 by removing idler pulley (1). Check that bearing (2) is positioned in center of idler pulley housing (1) as shown in figure 13. Hold idler pulley (1) as shown in figure 14, rotate spacer (2) by hand, and look for side to side movement of spacer (2). Turn idler pulley (1) over and check other side of spacer (2) for movement. Replace idler pulley (1) if bearing (3) is not centered or movement is found on spacer (2).

12. Check two upper idler pulleys (2) and updated configuration idler pulley (3) for loose or noisy bearing, by pushing in and pulling out on idler pulleys (2) and (3) and rotating and listening for noise as shown in figure 12. Replace idler pulley if bearing is loose or noisy. (Refer to TM 9-2320-280-20 or TM 9-2320-387-24.)

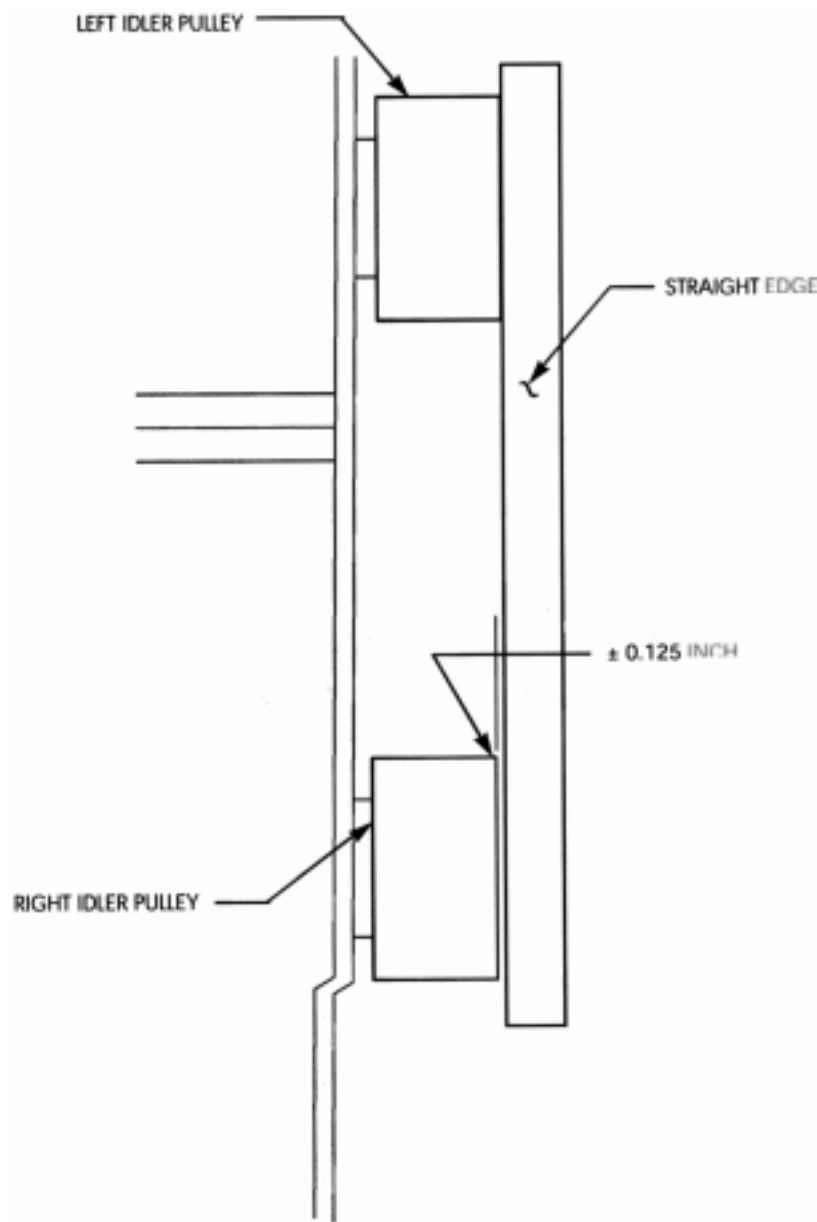
13. Check alignment of two upper idler pulleys by placing a straight edge on the left front pulley face and over to right pulley front face as shown in figure 15. Face-to-face clearance must not exceed  $\pm 0.125$  in. Replace idler pulley bracket if not within limits. (Refer to TM 9-2320-387-24 or TM 9-2320-280-20.)

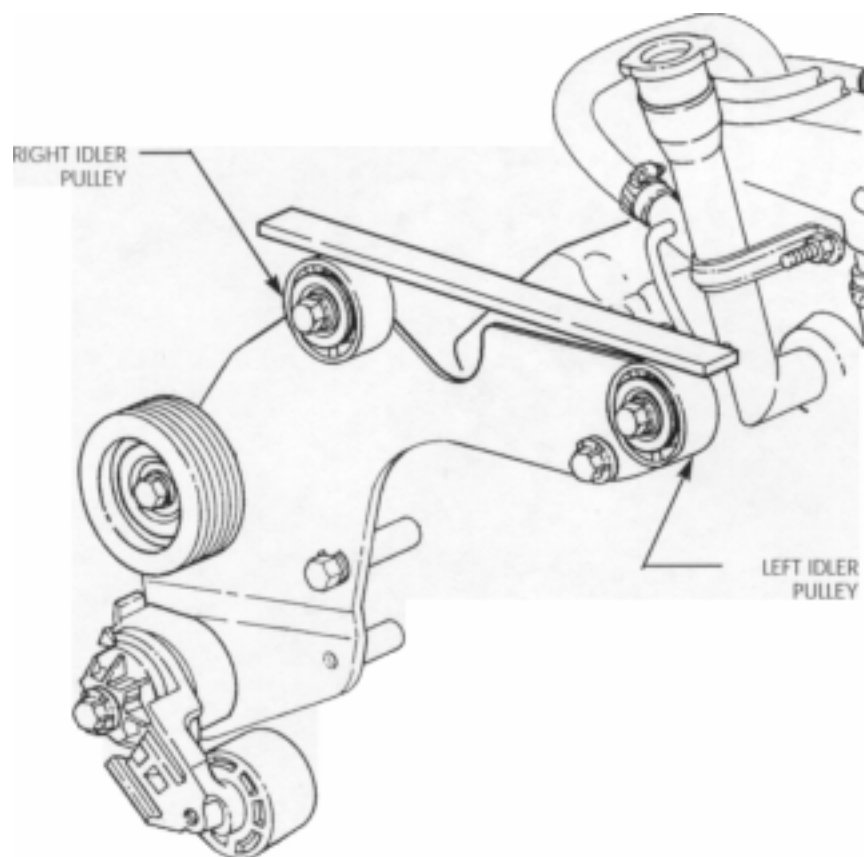
Figure 16

14. Check for alignment of the top two idler pulleys by placing a straight edge on top of pulleys and checking if straight edge rocks from side-to-side as shown in figure 16. Replace idler pulley bracket if pulleys are not in line. (Refer to TM 9-2320-280-20 or TM 9-2320-387-24.)

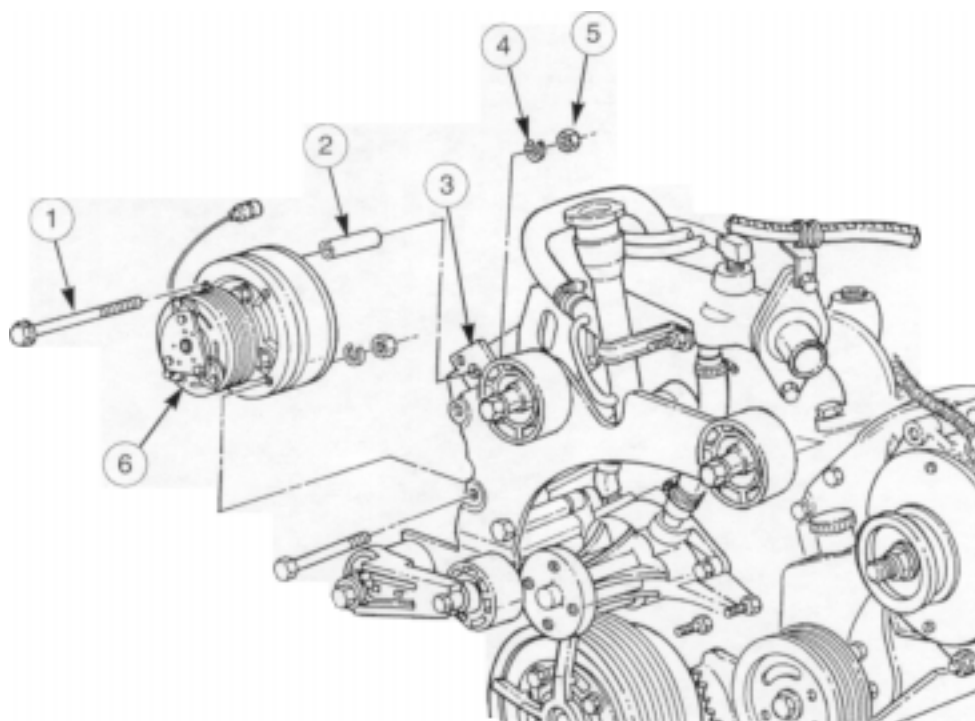
Figure 17

16. The original configuration, as shown in figure 17, has a welded bracket (3) and spacer (2) with overall length of  $2.575 \pm .010$  in. If spacer (2) is too long, grind length to  $2.575 \pm .010$  in. If spacer is short, it must be replaced. Use existing hardware to reinstall spacer (2).

19. Spin A/C compressor (6) clutch bearing, and check for noise, loose bearing, and signs of grease coming from bearing as shown in figures 17 or 18. Replace or repair A/C compressor as necessary. (Refer to TM 9-2320-387-24 or TM 9-2320-280-20.)

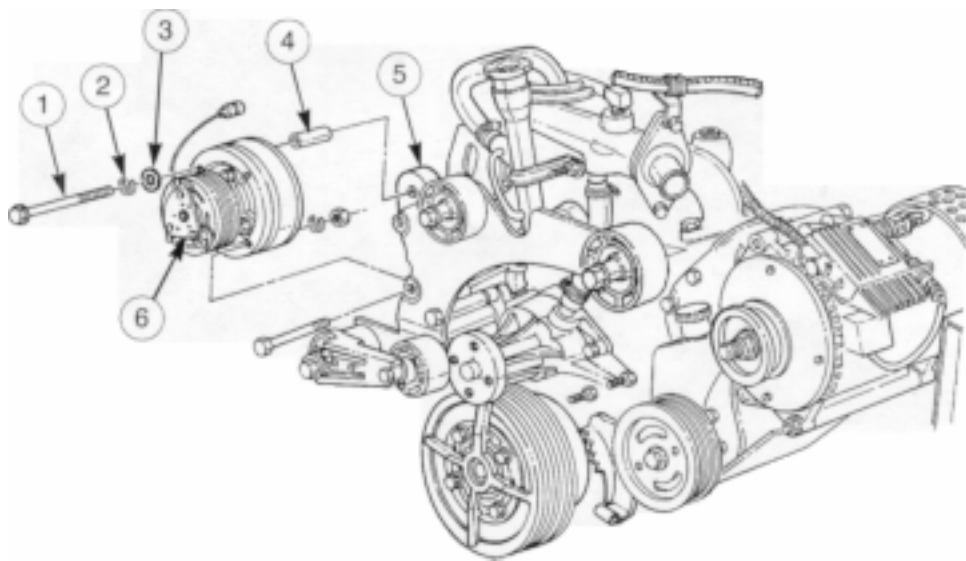
Figure 18

18. The updated configuration, as shown in figure 18, has a 1.00-in. thick adapter plate (5) mounted to cylinder head and spacer (4) has a length of  $1.825 \pm .010$  in. If spacer (4) is too long, grind to  $1.825 \pm .010$  in., or replace if too short. Use existing hardware to reinstall spacer (4).
